project VEX

designed by: Steven

date: 1.2.2

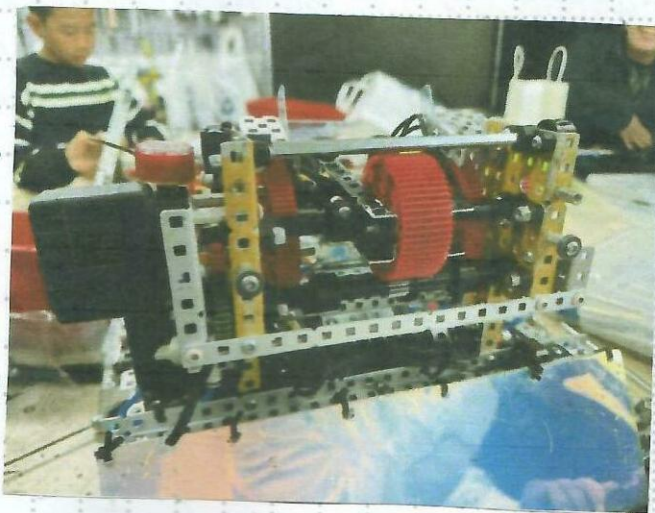
motor shafts deformed significantly under the excessive force, causing the 12-tooth gear to bounce and continuously rotate when reaching the end of the toothed section.

To address this problem, we replaced all the thin shafts with thicker ones. Due to limited space, we also cut a 36-tooth gear in half to fit it onto the thicker shaft.
